Total has appointed Artelia to supervise the construction of its first Total Access service station

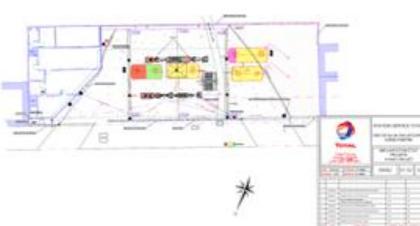
Storage facility installed

The second challenge concerned installing the hydrocarbon storage tank under the existing canopy, which was to be retained. The future widening of the road also had to be taken into consideration.

The initial project involved demolishing and rebuilding the canopy. Filing one application for a permit to demolish it and another to rebuild it would have forced the municipal council to reject the building permit and halt the project. An alternative solution was hence examined: dismantling the light structures on the canopy, in order both to replace the elements and to create an opening through which to pass two of the four tanks in order to position them between the canopy columns.
